PHOTOGRAPHIC INTELLIGENCE REPORT

LO-YUAN AMMUNITION DEPOT SW, CHINA
(FORMERLY SUSPECT CW MUNITIONS STORAGE)

CIA/PIR 63025

DATE DEC 1965

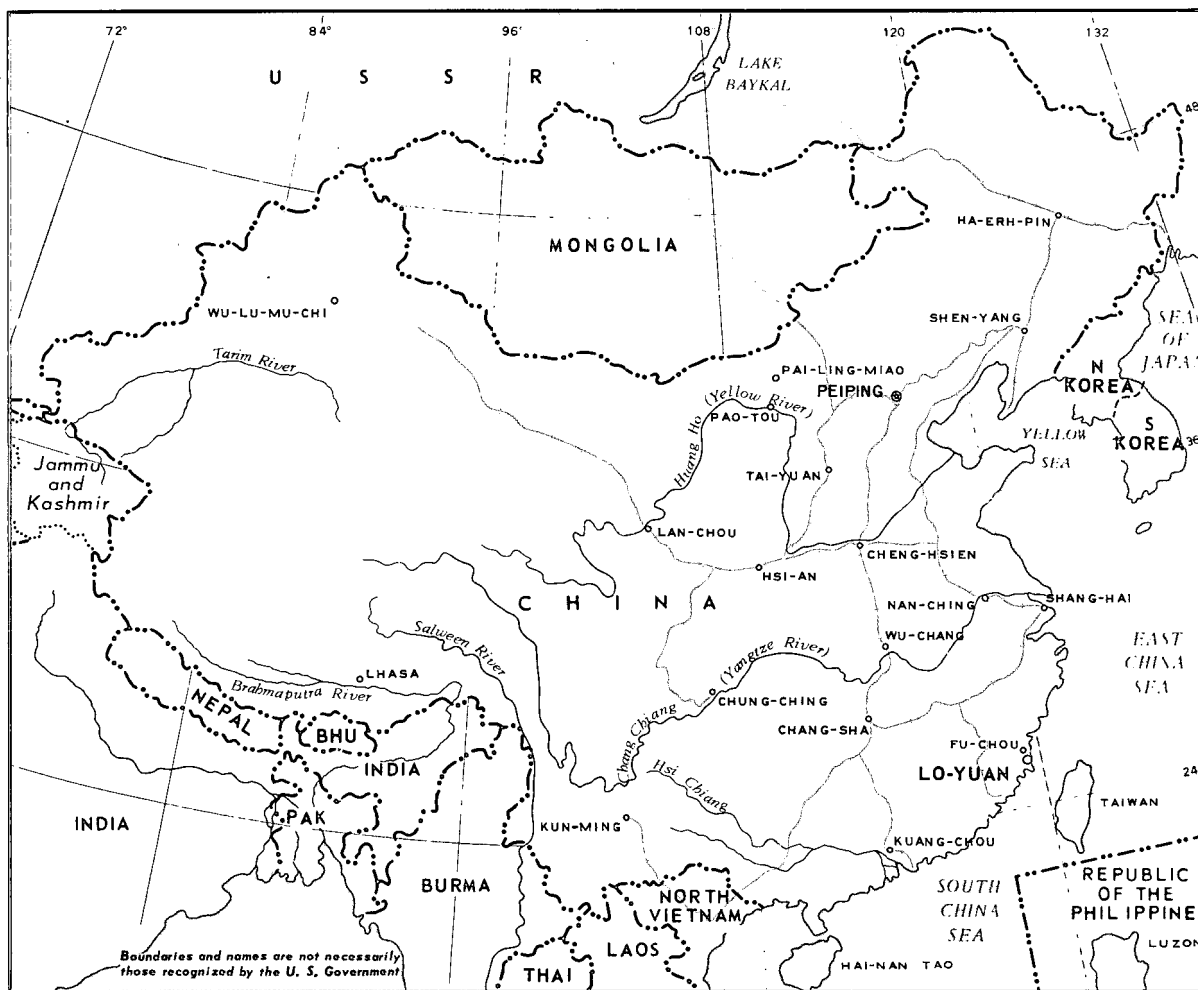
FIGURE 1.

A previously identified munitions storage site is located at 26-30N 119-32E, 0.4 nautical mile (nm) south of the city of Lo-Yuan, China (see Figure 1).

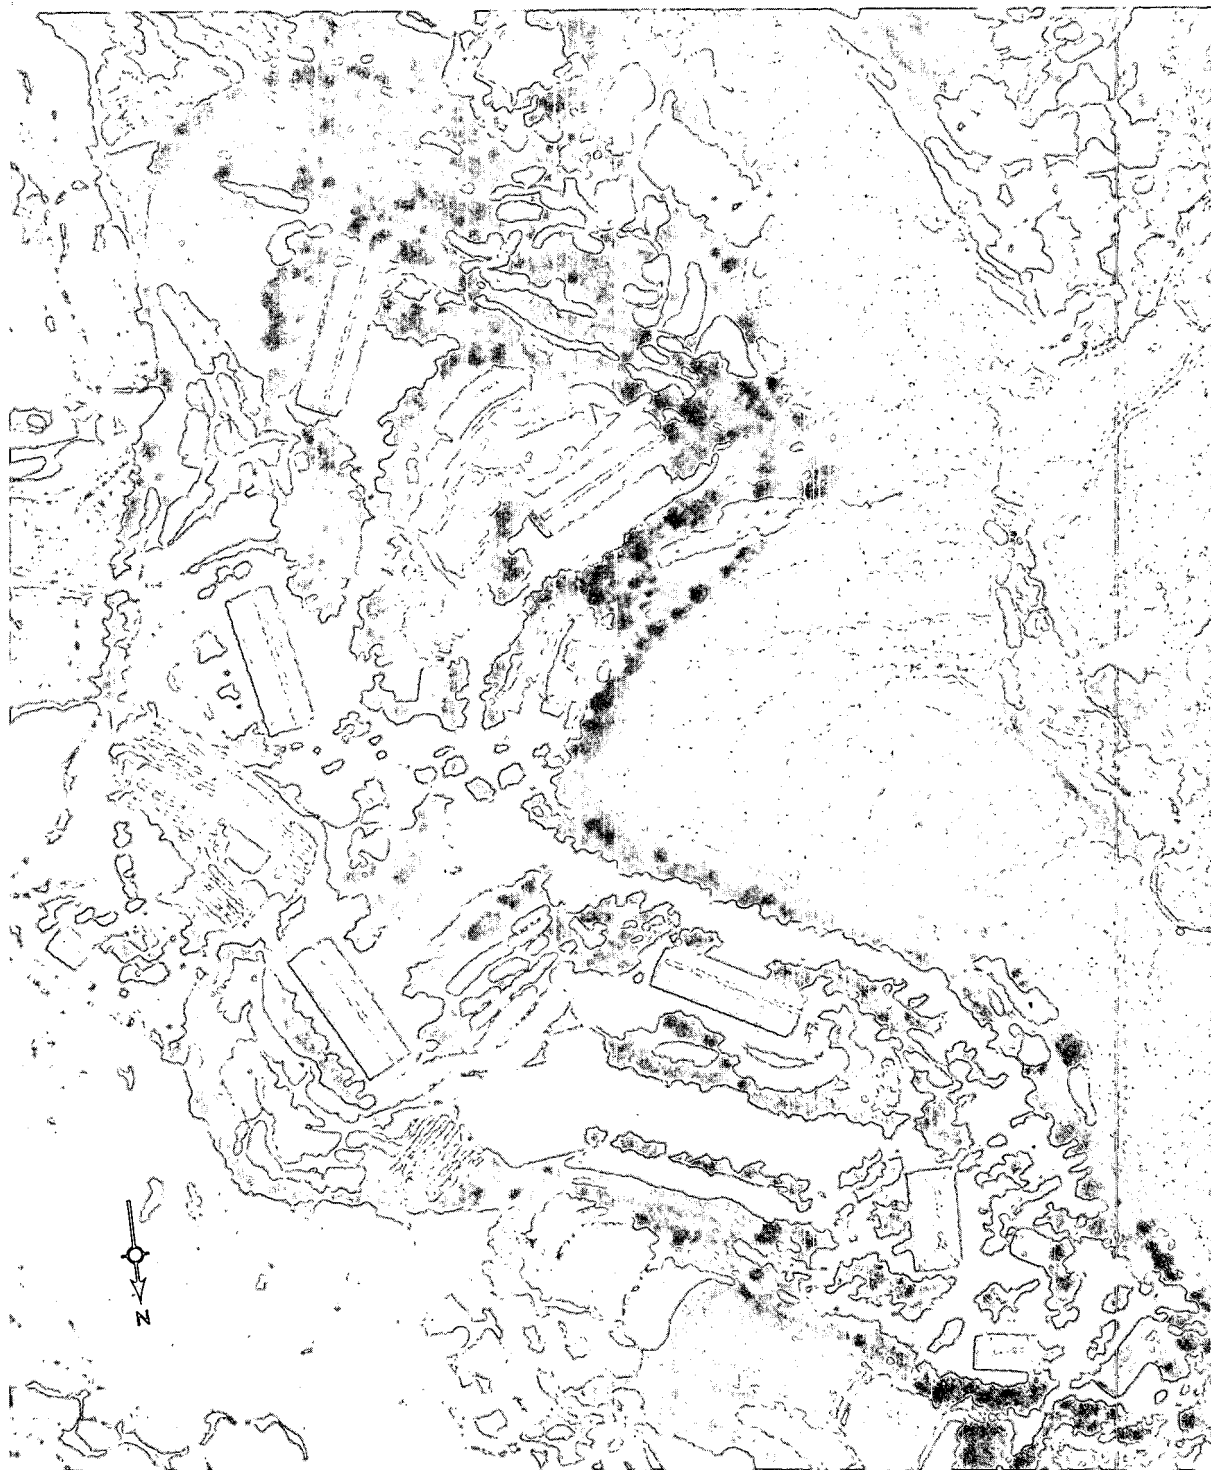
FIGURE 2. LO-YUAN AMMUNITION DEPOT SW, CHINA.

This site consists of five large gable-roofed warehouses, one smaller storage/service building and a small shed. Three of the warehouses (Buildings 1-3, Figure 3) have been constructed on aprons which have been cut into the hillside.

Security at the site is provided by two guardhouses located on hills adjacent to the storage area with associated observation points and a guardhouse at the road entrance. The wall which secured the site in [] is no longer visible on the most recent aerial photography. An intermittent line of trees surrounding the site approximates the position of the wall which was visible on the earlier photography. Terraced fields within the storage area are under cultivation (see Figure 2). The apparent downgrading of security measures at this site is not consistent with practices for CW storage.

The administration and barracks area consists of three buildings, an athletic field and a guardhouse and is located within the storage area near the road entrance. The wall which separately secured this area in [] was no longer visible in []
